Creating an Anticipatory Management Plan for Carneros Creek, Napa CA

Master of Landscape Architecture

University of California, Berkeley

Spring 2010

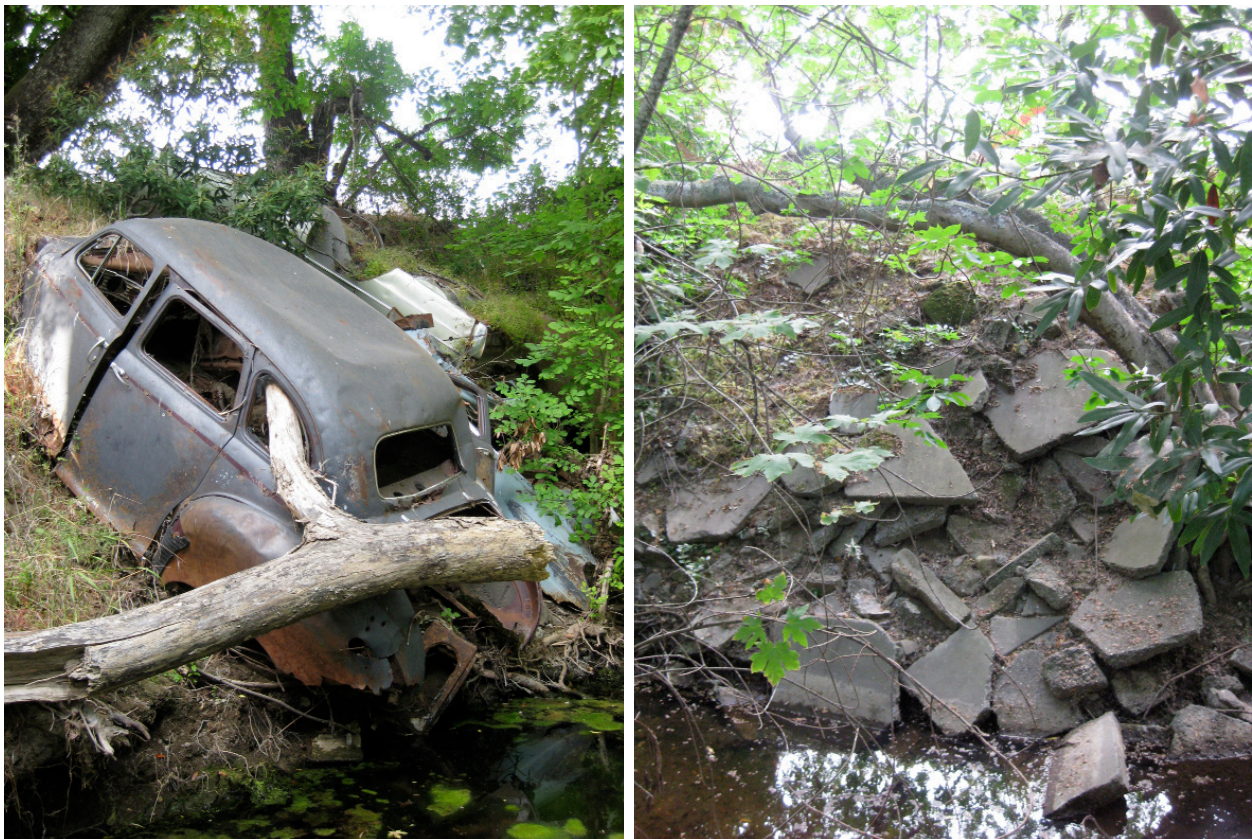
Figure 1.1. Examples of bank hardening on Carneros Creek

This hardscaping, aside from creating poor aquatic habitat, increases velocities and shear stresses even further against downstream banks, encouraging more bank failures, and continuing the cycle.

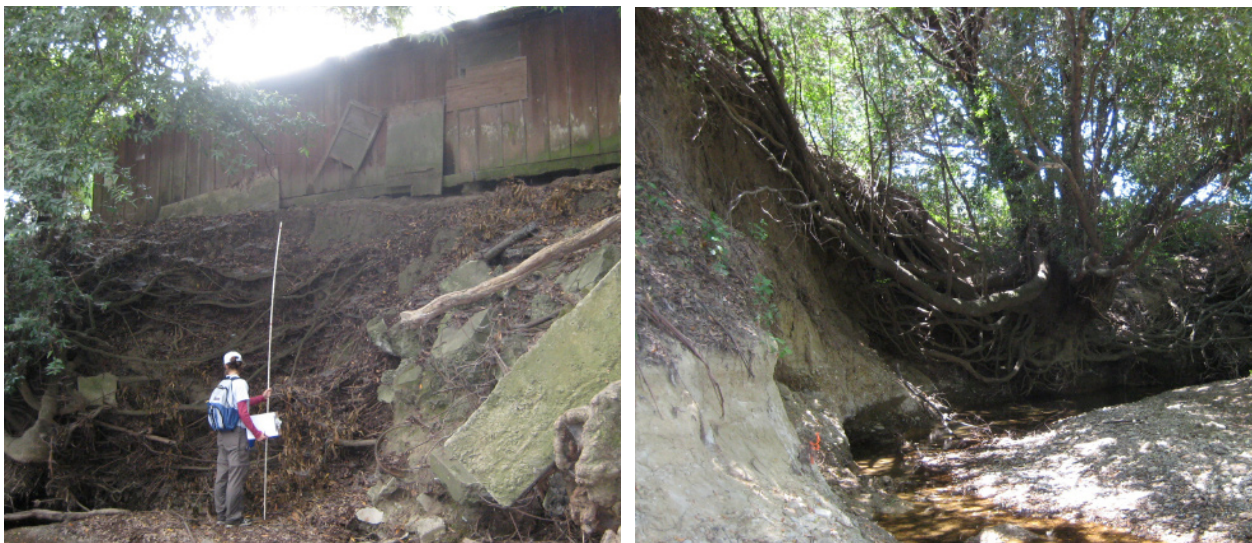
*Figure 1.3. Incised banks and sinuous stream*

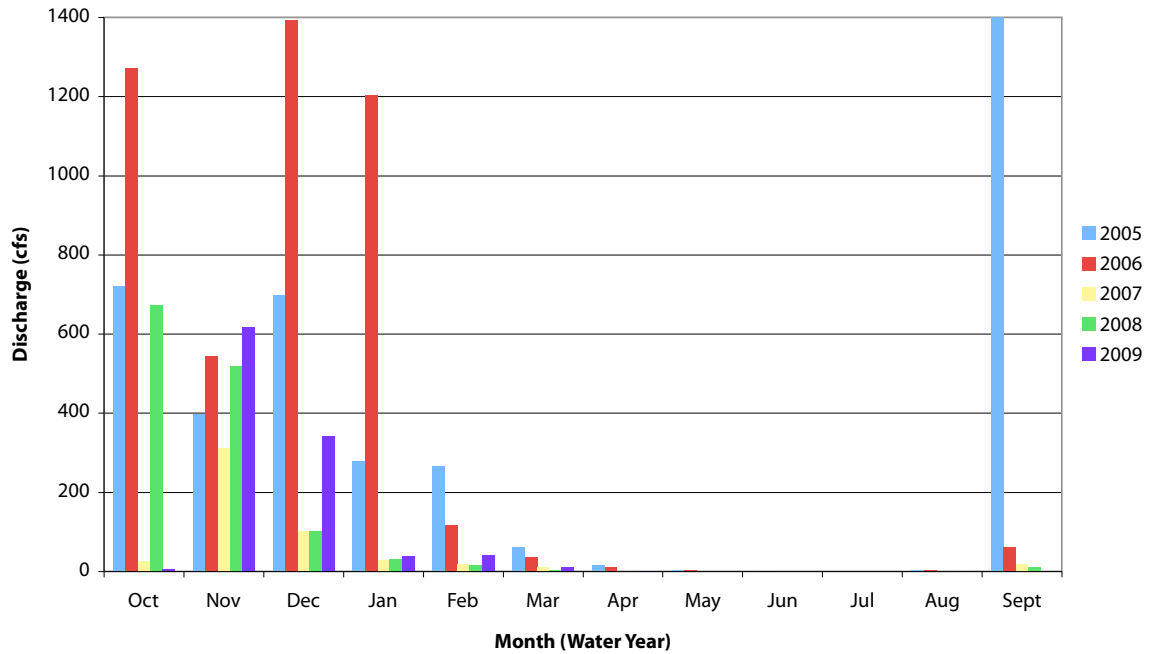
**Mean Monthly Flow 2005-2009  
Napa River**

**Mean Annual Discharge  
Napa River**

Figure 2.5. Mean annual and mean monthly hydrograph for Napa River, CA.

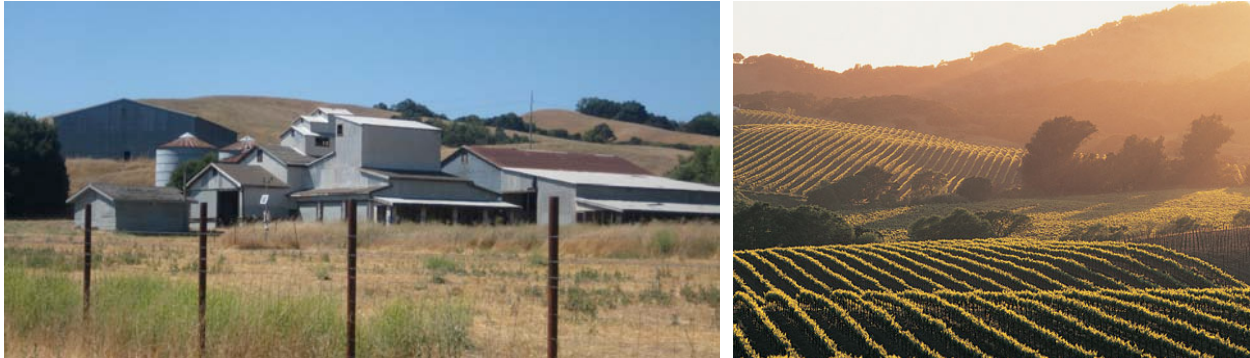
*Figure 2.7. Closed dairy in upper Carneros Watershed and vineyard monoculture (source: Caldwell Cellars)*

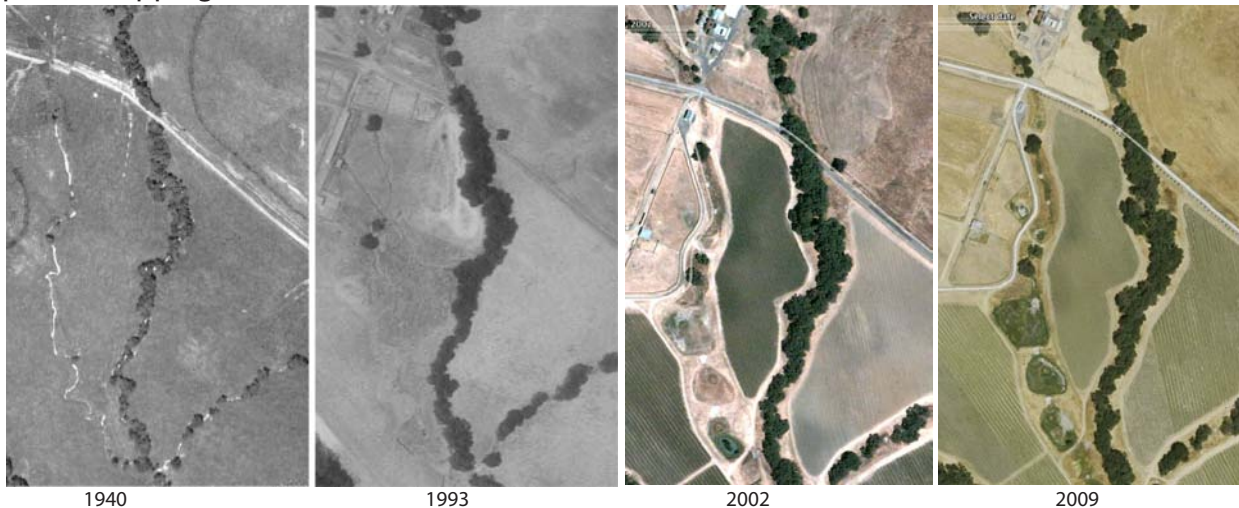
The images below document these changes in these land uses over time. An increased riparian corridor between 1940 and 1993 indicates that when cattle are removed from a landscape, there may be a rebound effect of previously trampled vegetation and compacted soil. However between 1993 and 2009, the photographs exhibit the rapid expansion of vineyards, and of management of the tributary on the left in the form of step ponds, trapping sediment.

Figure 2.8. Change in land use over time in upper watershed (1940, 1993 from Grossinger et al., 2003) (2002, 2009 from Google earth)

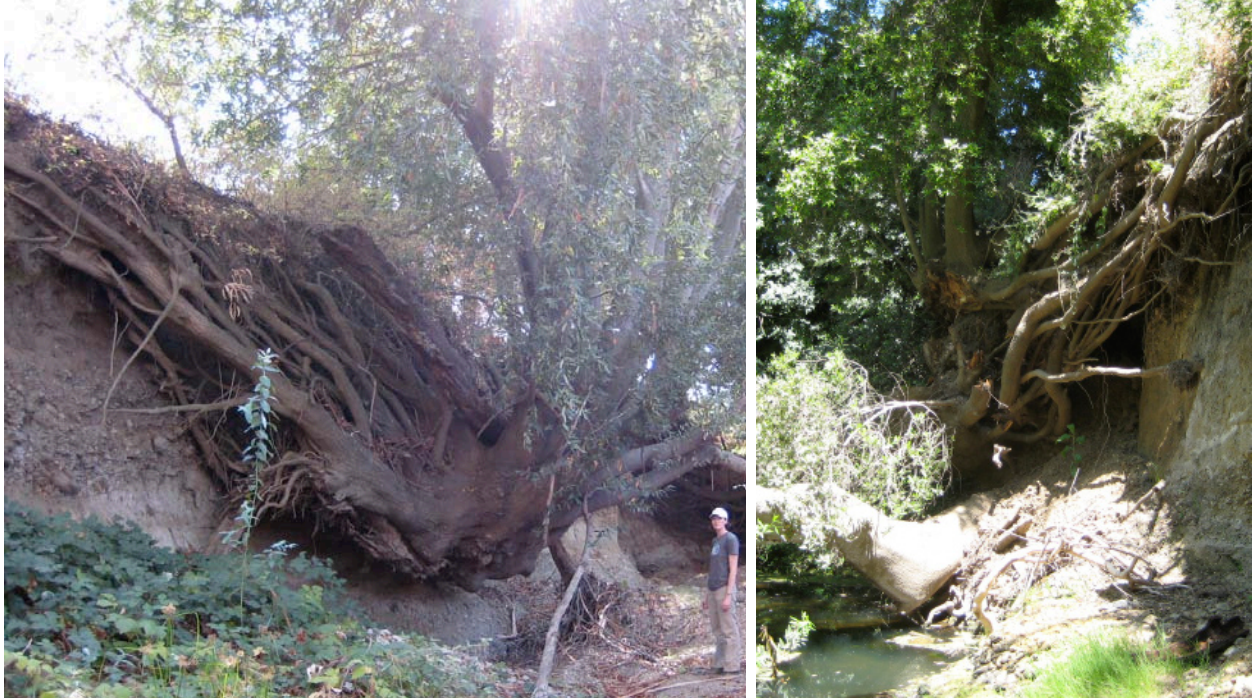
In each reach, I mapped location and species of 'spider trees.' This describes a growth form that is common in entrenched river systems whereby a tree establishes on a river bank, and as the bank erodes away and the channel bed drops, the trees roots are left hanging over the edge of the bank, recalling the legs of a spider. I define a 'spider tree' as one whose roots are more than 1/3 exposed in mid-air, indicating that the soil structure originally supporting the tree has been eroded away. The spider trees on Carneros Creek are balanced at an equilibrium, where their roots hold them up on the banks and their branches splay out over the channel. I also mapped the location and angle of large woody debris that crossed at least half of the channel bed.

Figure 3.5. Example of spider tree (left) and fallen spider tree (right)

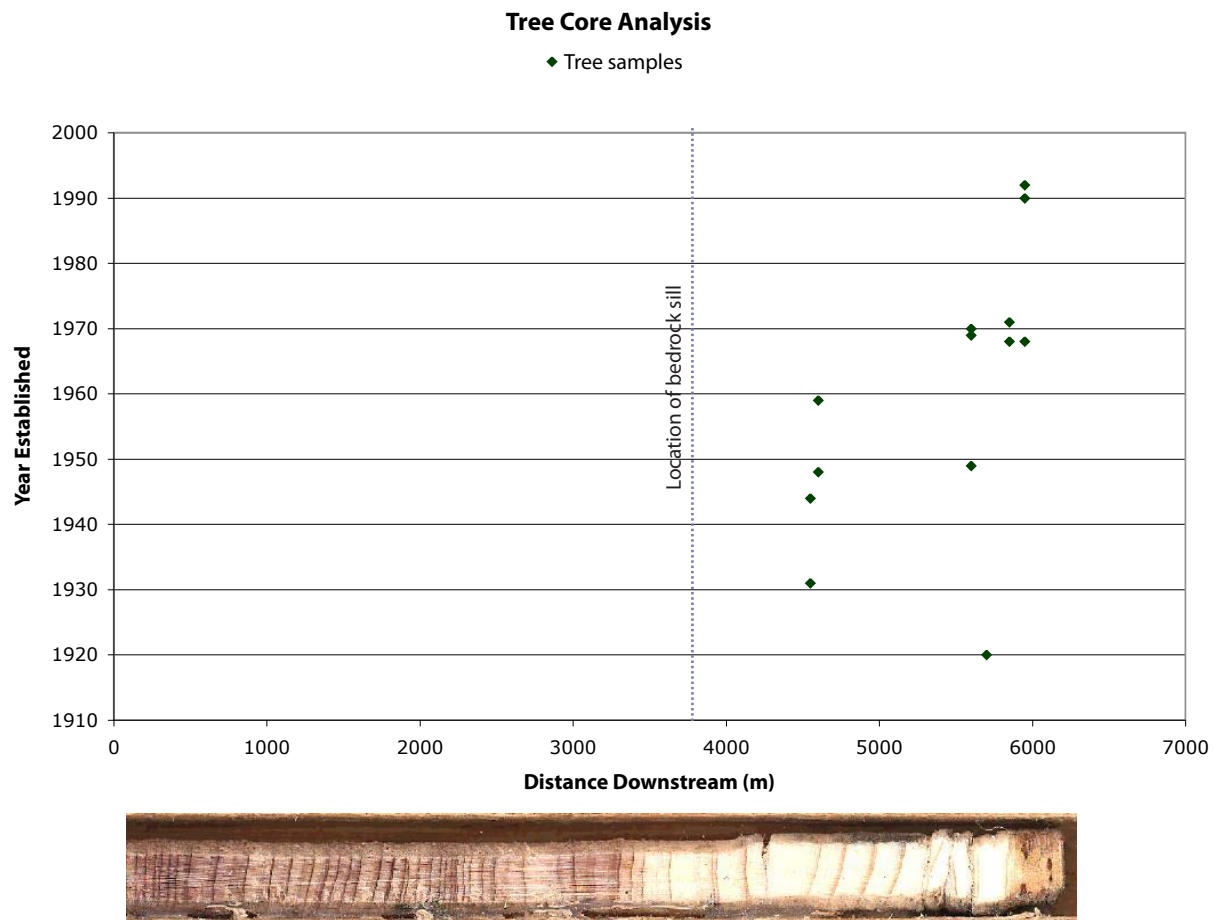
Figure 5.1. Results of dendrochronology study

The results of this tree core analysis show that the willows established between 16 and 88 years ago, between 1921 and 1993. The average age of the trees are between 50 and 65 years, corresponding to the transformation from diverse agriculture to vineyard, from 1960-1975. This suggests that the terraces correlate to the second episode of incision, indicating that two episodes occurred.

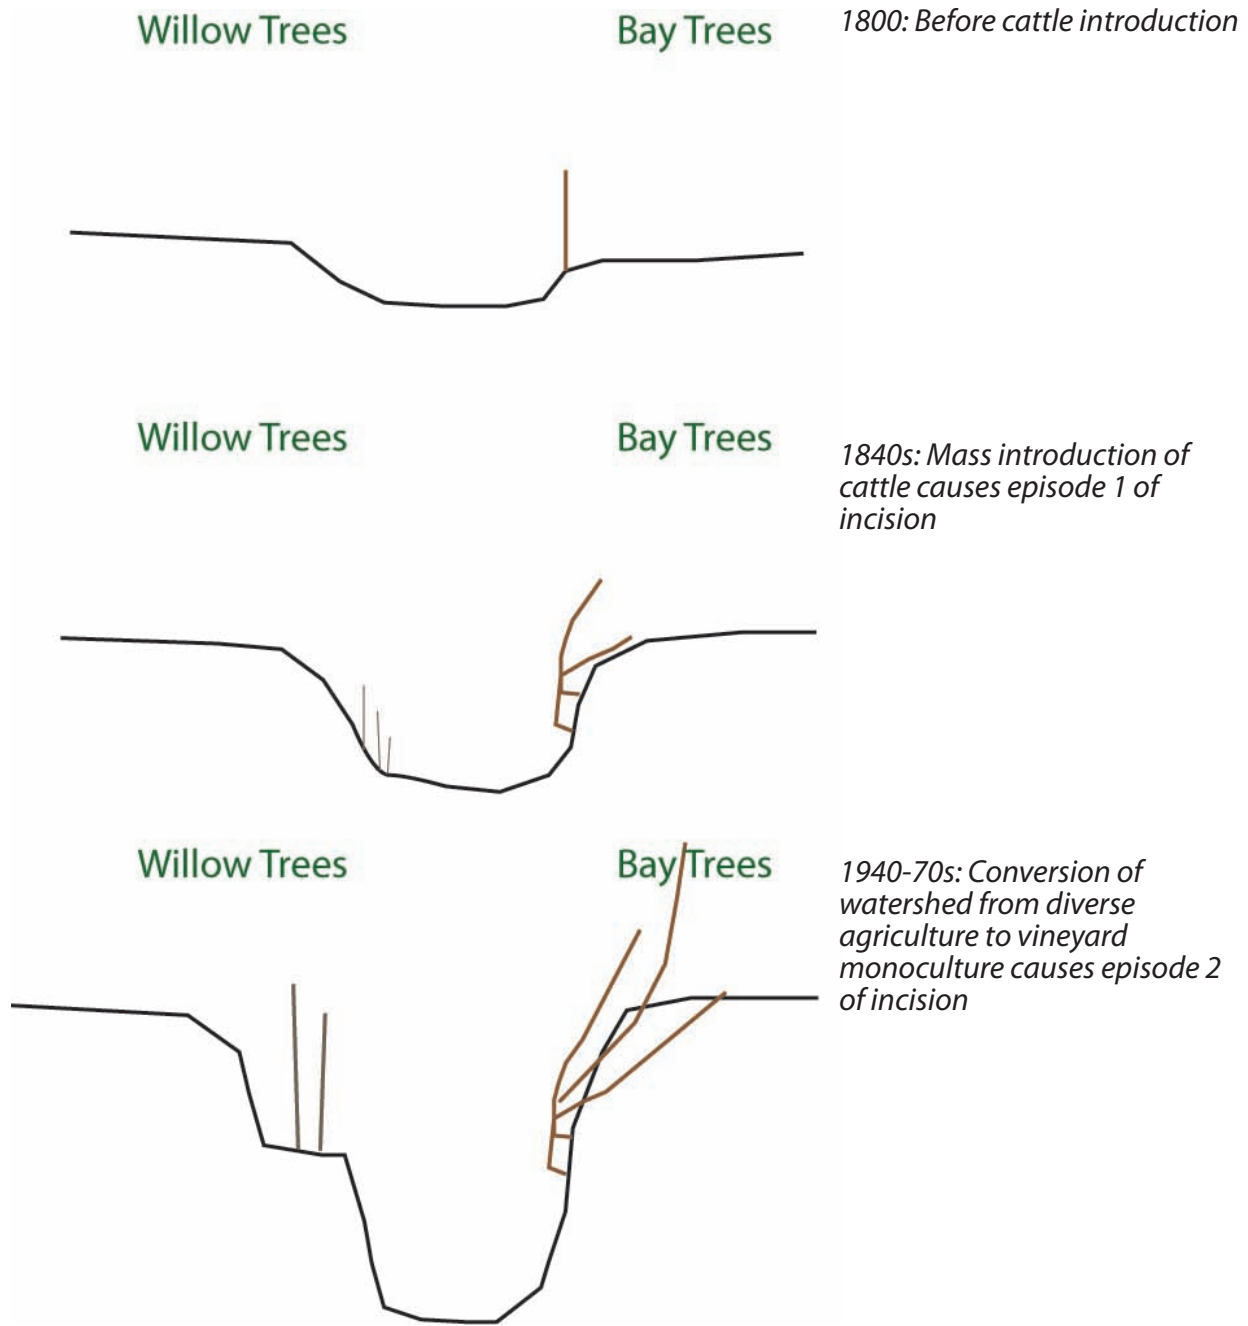
Figure 5.2. Diagrammatic sections showing evolution of channel over time

The legacy terraces are left from the second wave of incision that took place as vineyards were introduced on a commercial level to the watershed. Increasing cultivated land, subsurface drainage and the introduction of small reservoirs for water storage and frost control limited sediment transport and increased runoff, causing the channel bed to drop in elevation.

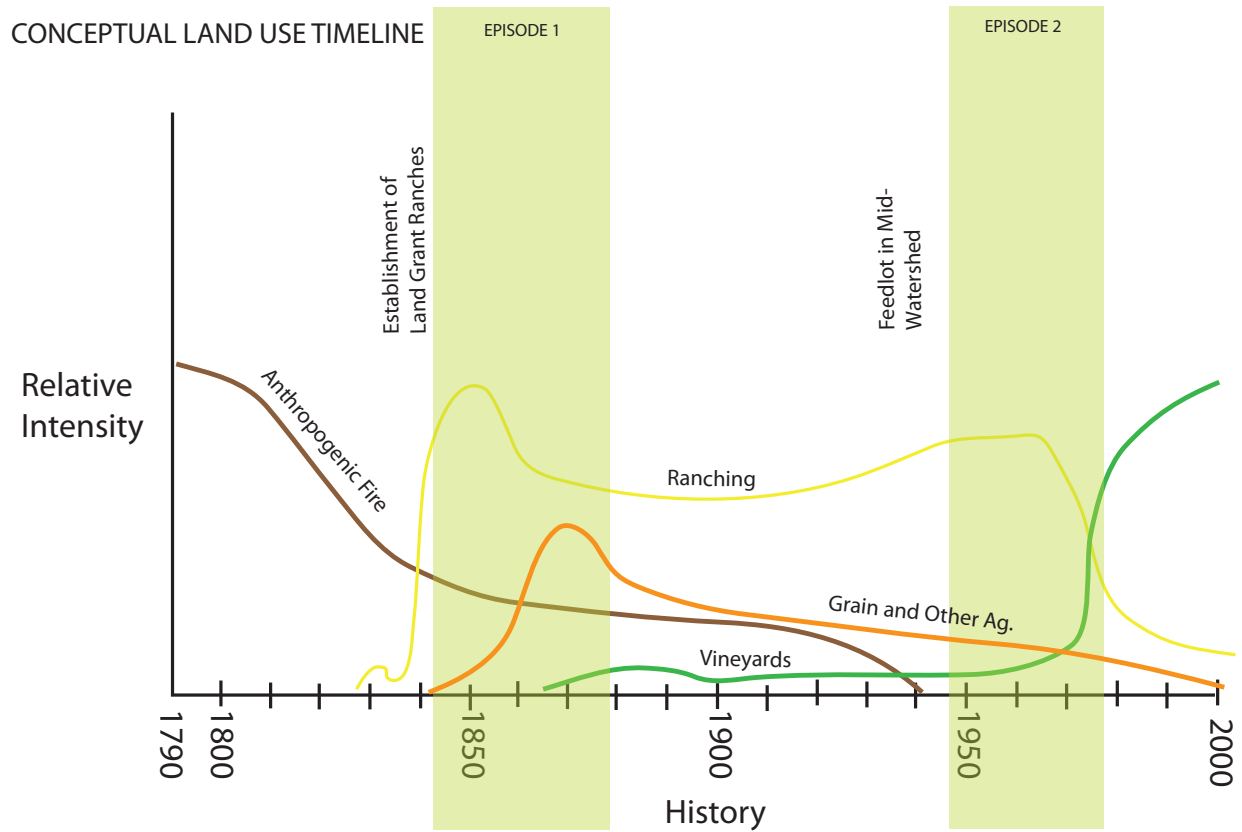
Figure 5.3. Land use conceptual timeline with episodes of incision (adapted from Grossinger et al., 2003)

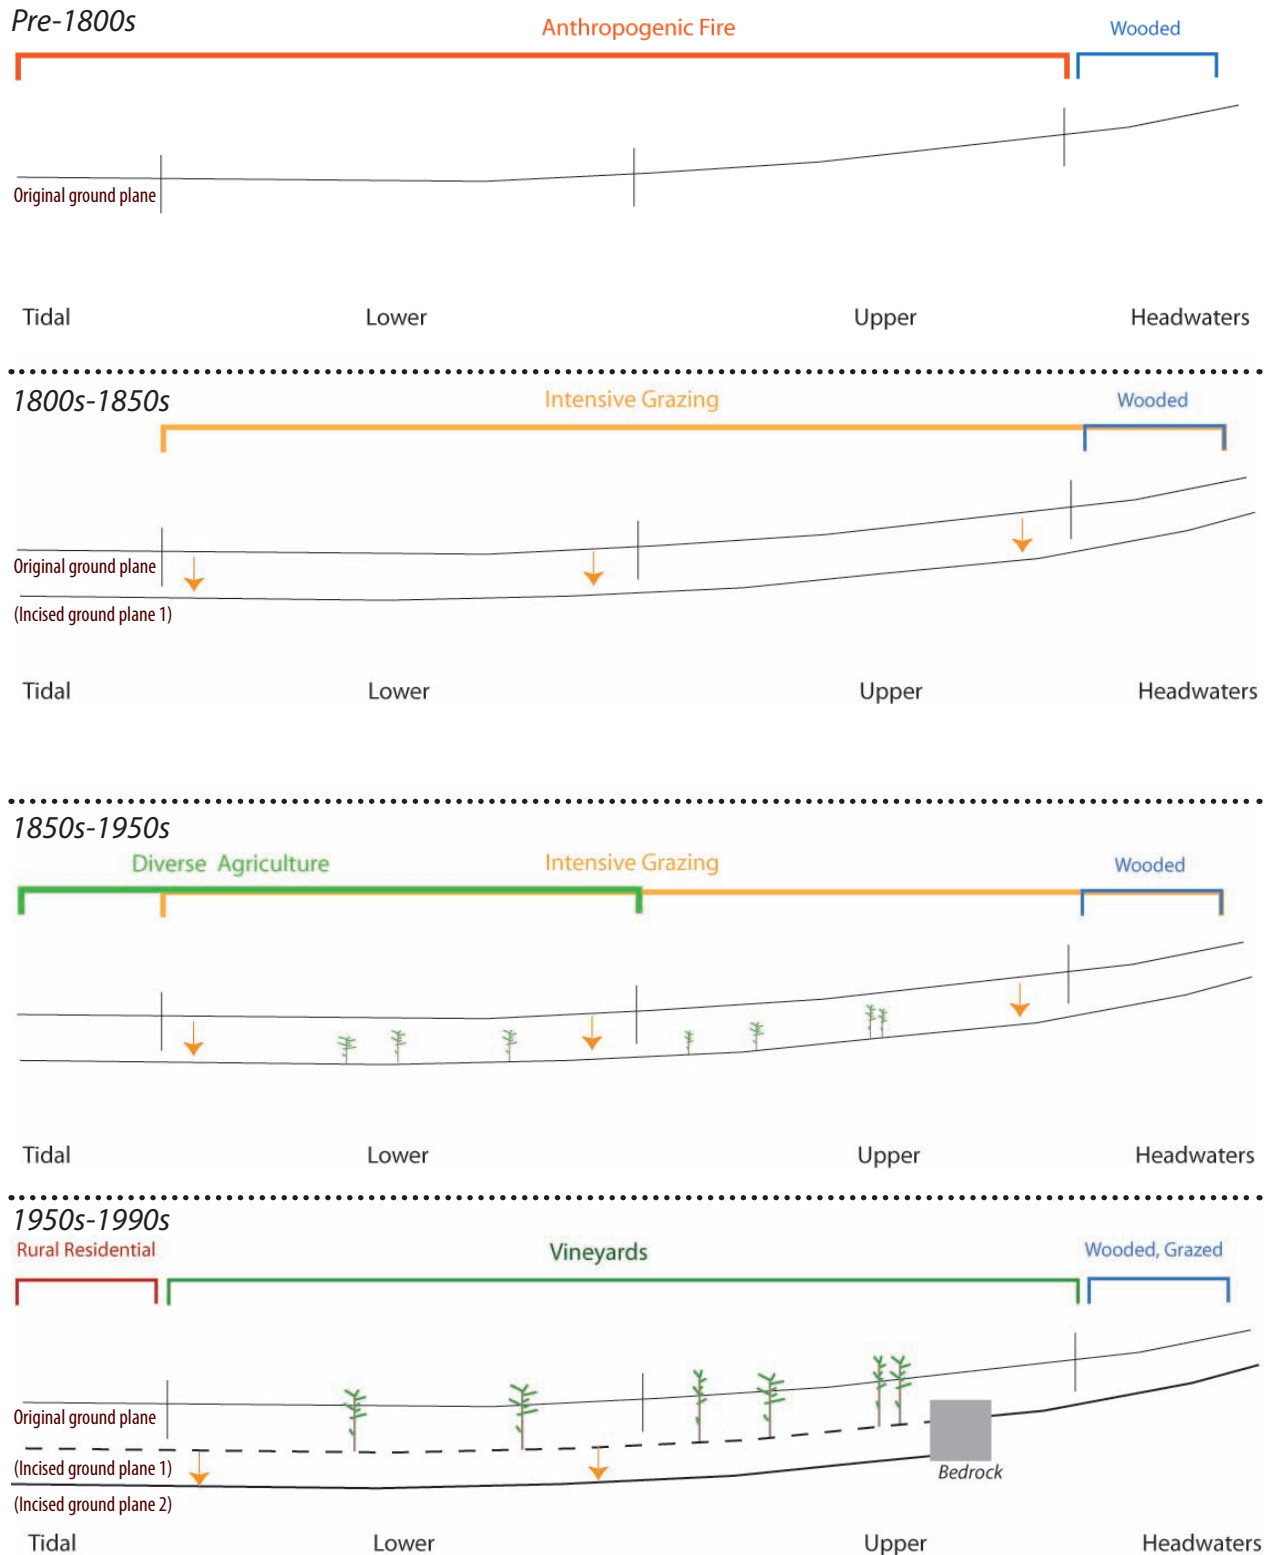
Another way to understand the evolution of channel form is shown by looking at the long profile of the creek in relation to land use over time.

Figure 5.4. Long profile schematic of channel incision over time

The sandstone bedrock sill, in the middle part of the watershed below the tributaries (polygon 80), seems to be acting as a control against the second wave of incision. There are no terraces upstream of the sill and bank heights are significantly lower, averaging 1-3 m. Given this theory of land evolution, and that the sandstone sill acts as a grade control, it is important to look at the current trends within the channel.

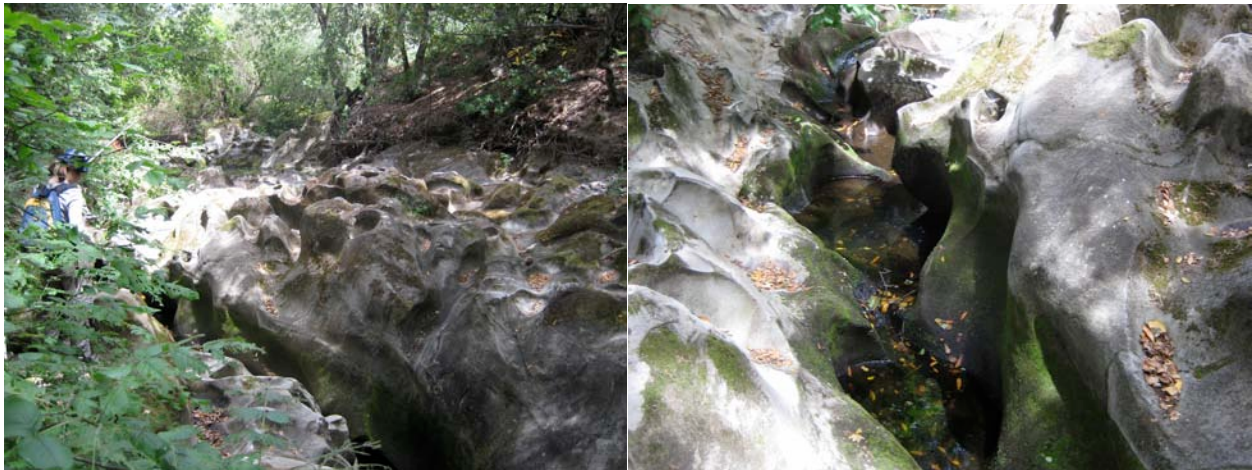
Figure 5.5. Bedrock Sandstone sill in reach 80. It is 75 m long

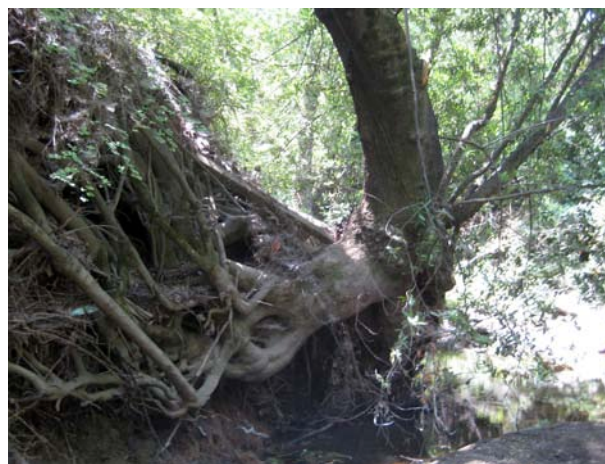
More evidence for the timing of down-cutting is seen in the shape of the “spider trees,” usually California Bay Laurel (*Umbellularia californica*) which dominate the riparian corridor. Bay trees are members of the avocado family and are legacies of a warmer climate in California. This growth form allows their roots to slowly adapt to changing bank structures. This is unlike most oak species whose roots do not adapt as well to changing bank structures. The rootballs of the Bay Laurel trees throughout the channel have rotated to allow the roots to grow up onto the banks.

Figure 5.6. Roots of *Umbellularia californica* (California Bay Laurel)

This rotation takes decades and is most likely a remnant of the primary down-cutting which took place in the mid 1800s (T. Dawson, Pers. Comm. May 2009). In the downstream reaches of the channel, below the bedrock sill, the bay trees have rotated their rootballs and are now suspended between 1 and 3 meters above the channel bed. Above the sill, the rootballs have rotated, indicating that this happened uniformly across the channel at one time. However, the rootballs are flush with the channel bottom, indicating that the bottom of the channel has not dropped in these areas as they have in the areas downstream of the sill.

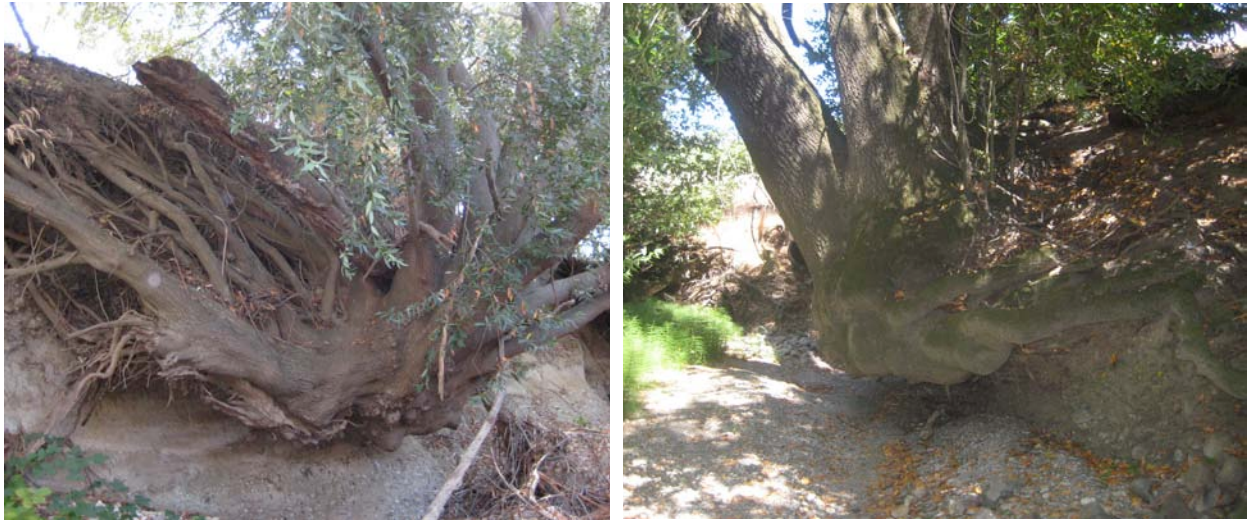
*Figure 5.7. Typical Bay Laurel downstream of sill. Upstream of sill (both with rotated rootballs)*

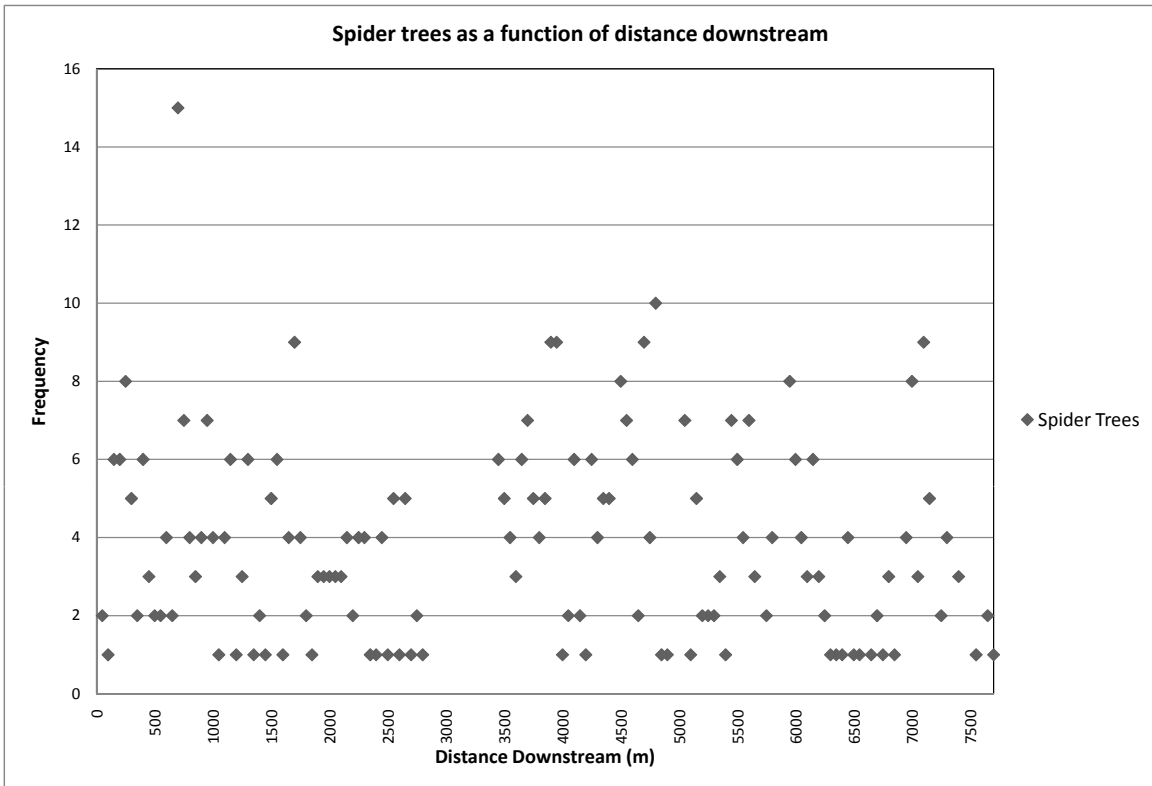
By looking at trends over the whole creek, I was able to make several observations of patterns and processes acting on the watershed. For example, Figure 5.9 shows spider tree frequency as a function of distance downstream. There is not a distinct pattern of distribution of spider trees upstream or downstream. They are a constant feature on the creek as a whole.

Figure 5.9. Spider trees as a function of distance downstream

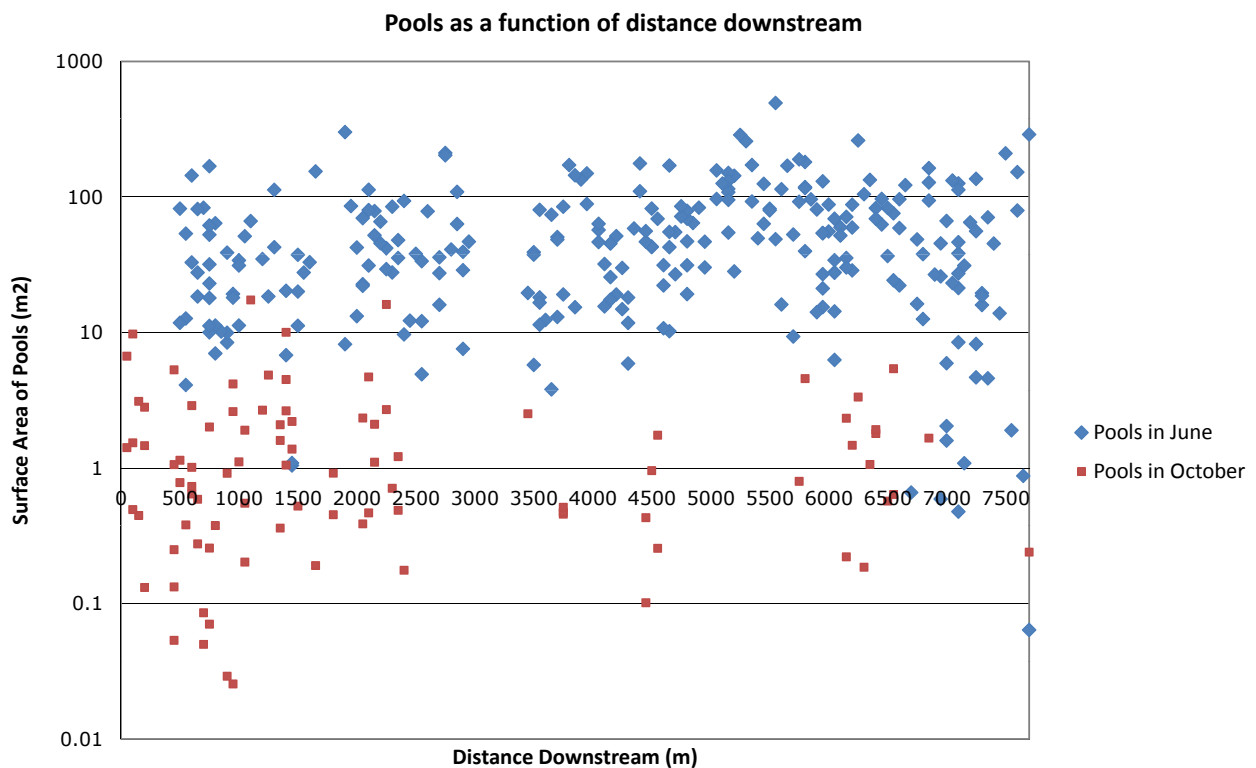
By remapping the remaining pools in October 2009, I was able to determine where, in a drought period, fishes would be able to survive over the summer. The majority of pools that persisted were perched in bedrock. Many of these did not change depths over the summer, indicating that they may be spring fed or filled by irrigation drainage. These perched pools tended to be upstream of the sandstone sill. Below the sill, pools that persisted tended to be near large woody debris, or near a spider tree, which indicates that the scour occurring at these two features creates an environment where water can remain over the summer. Of a total of 275 pools (average depth 0.61 m) mapped in June 2009, 96 pools remained (average depth 0.25 m). Total surface area in the pools decreased to only about 1% of the extent of water in June. I saw fishes in 63% of the pools in June, and only 22% of the pools in October, though this may have been because of the time of day, or life stage.

Figure 5.11. Pools as a function of distance downstream

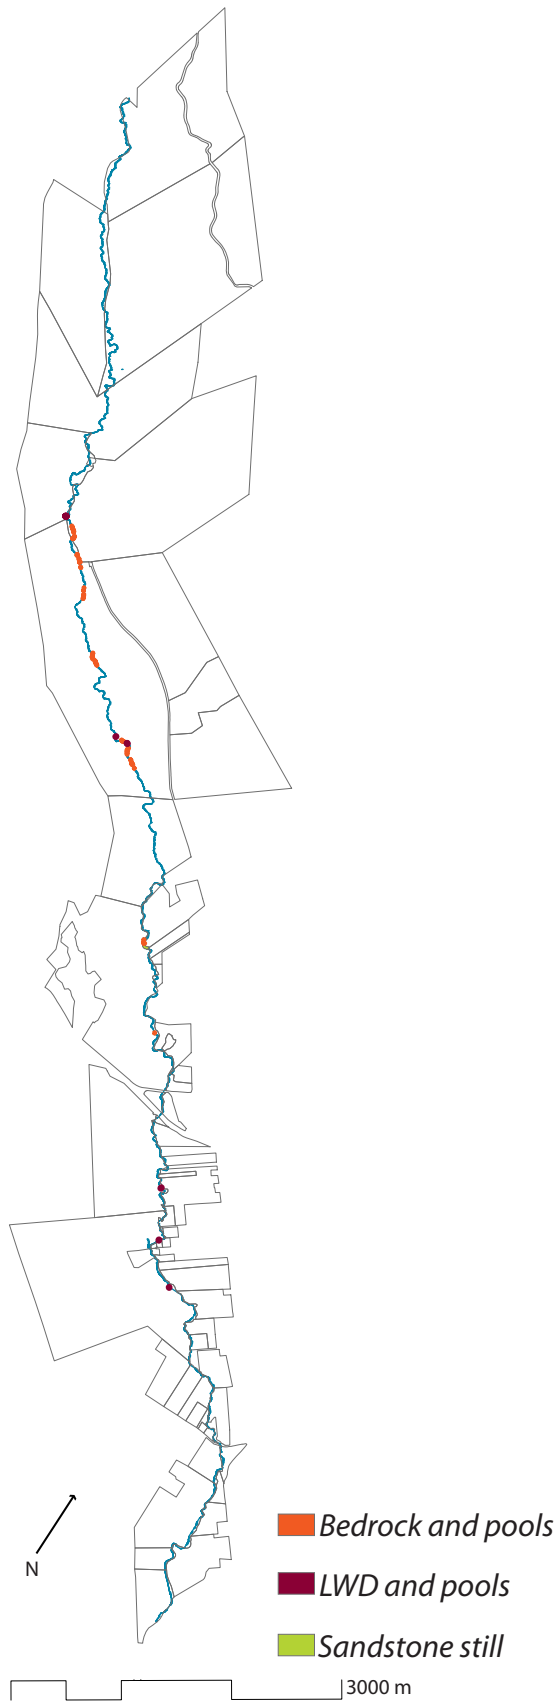
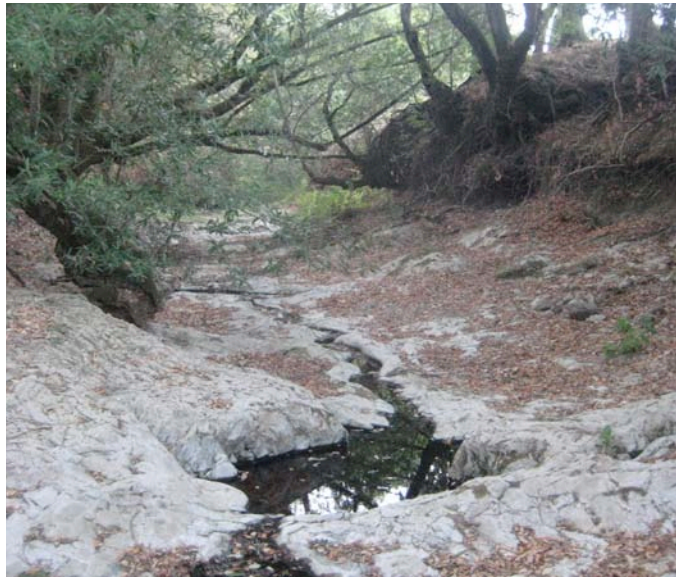
Figure 5.12. Pools persisting through October 2009 correlating with LWD and bedrock

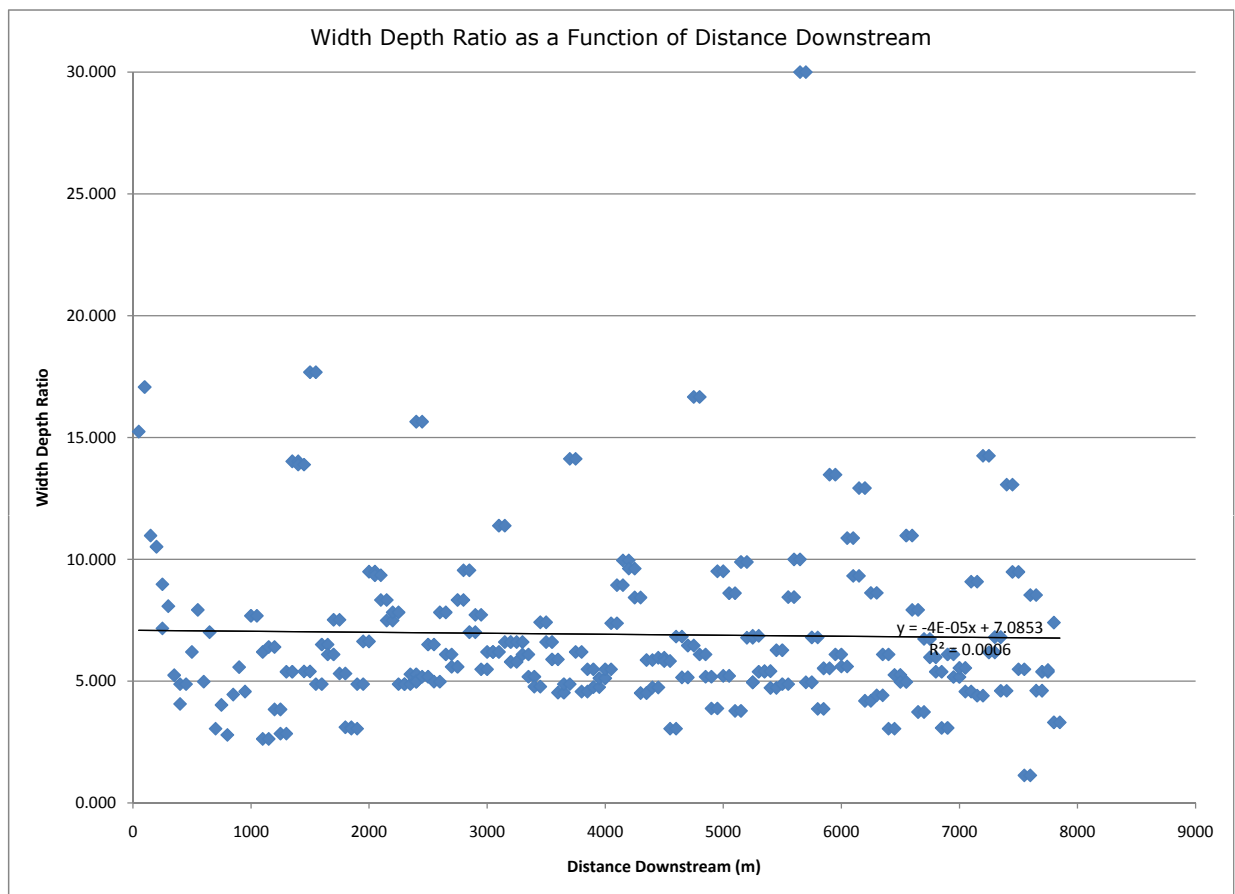
Figure 5.16. Width-depth ratio shows no clear trend with distance downstream

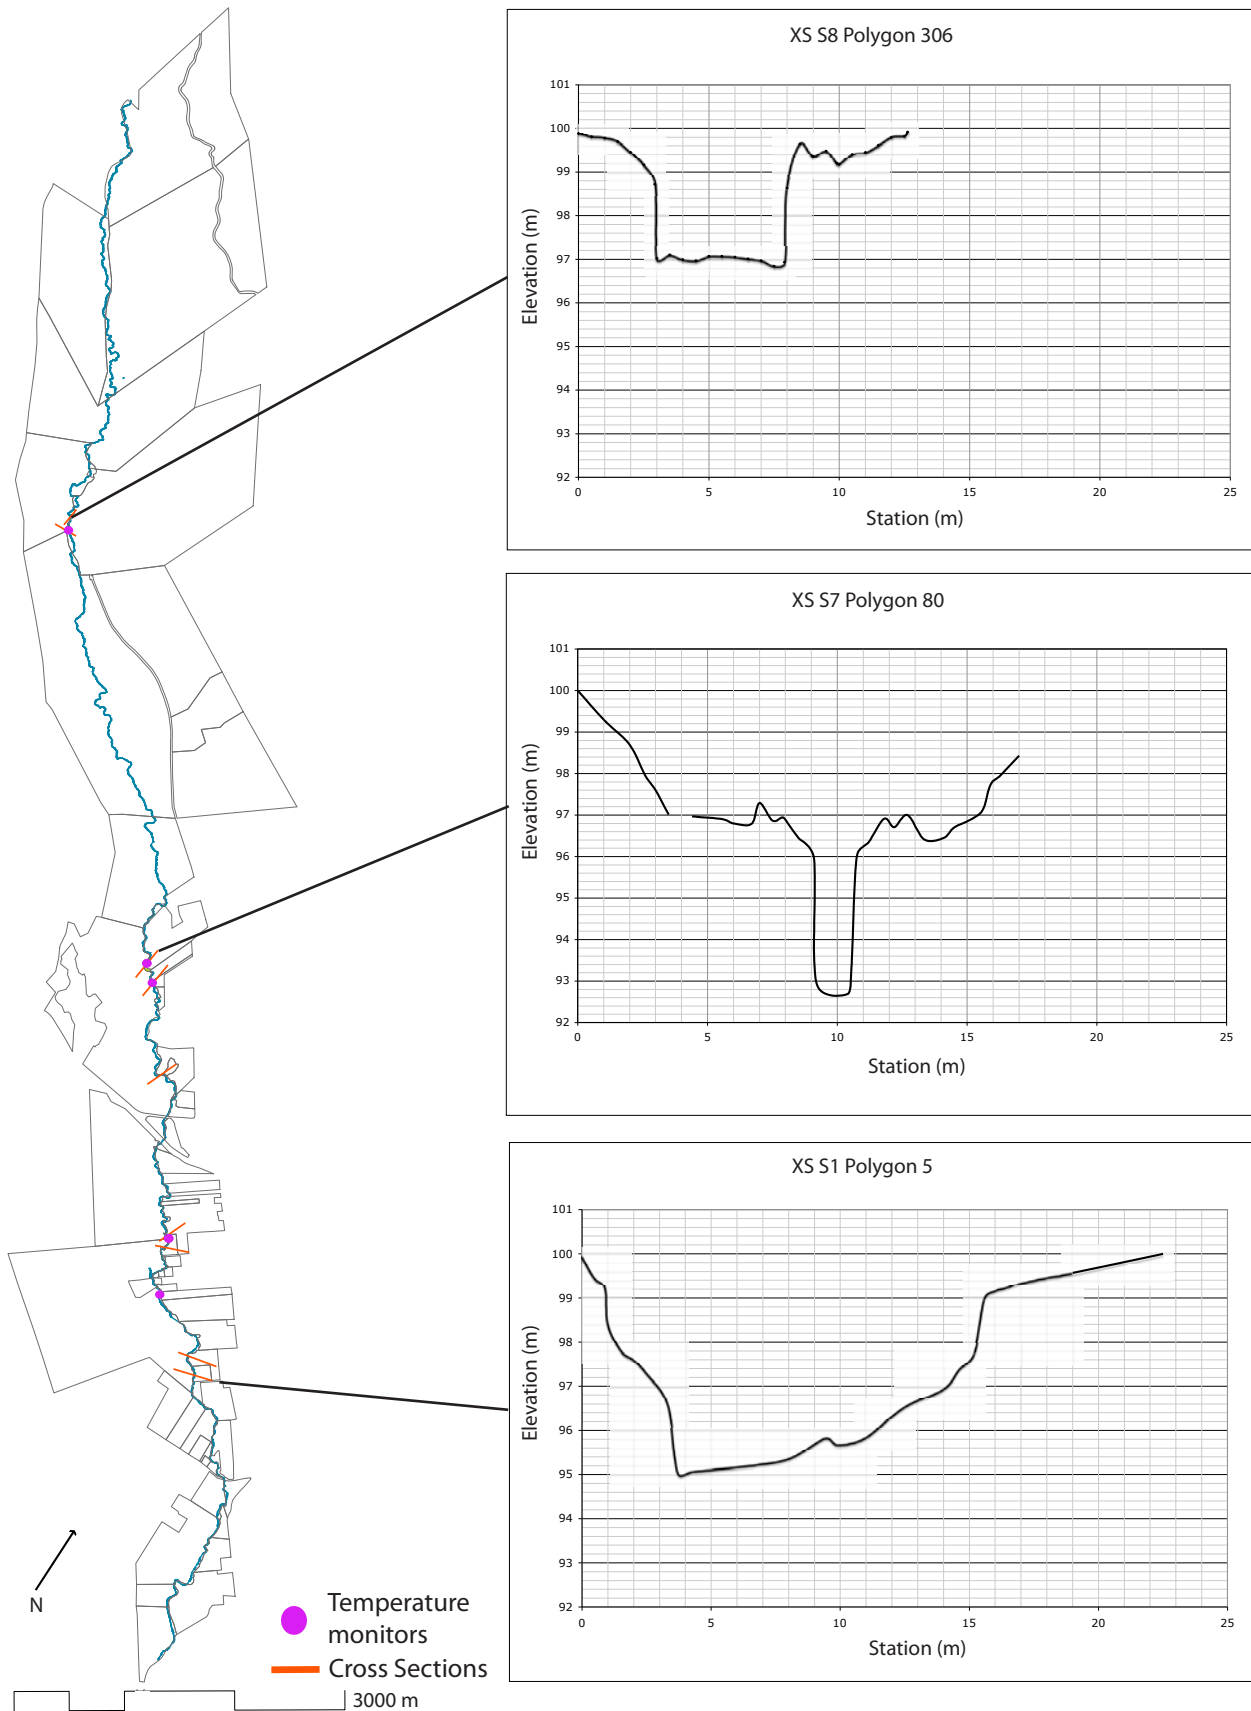
Cross sections were sited to be representative of the channel conditions over longer reaches of the stream. I surveyed nine cross sections and long profiles in July 2009 (Appendix A). The cross sections are meant to serve as a baseline dataset and should be resurveyed in the future. The highly sinuous nature of the stream does not lend itself to generalization of hydrology data or 1-dimensional modeling such as Hec-Ras. The two lines of tracers placed in the lower part of the watershed respectively, following a flood with return interval of about 1.5 years (2/9/2009), showed partial and complete mobility. The cross-sections and long profiles are illustrative of the varying forms of the channel geometry.

Figure 5.17. Sample cross sections surveyed summer 2009 and location of temperature loggers

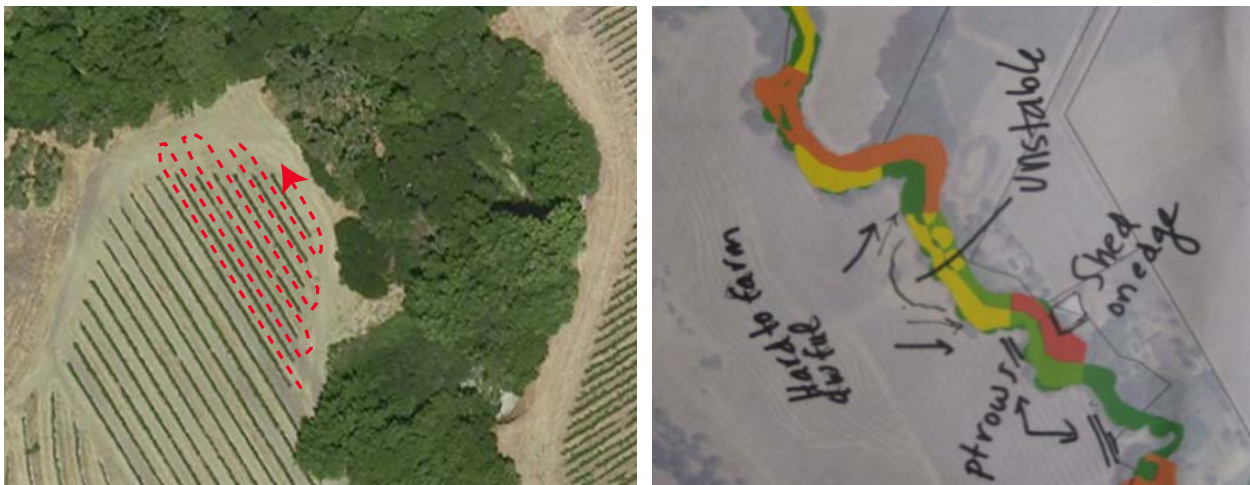
Figure 5.19. Example of “point rows” in a meander bend, and example of landowner feedback

I presented the results of the predictive bank stability model to the land managers to check the accuracy of my predictions. In general, the model seemed accurate, though it may have underpredicted the severity of the bank instability conditions. Both vineyard managers linked the principles of geomorphology and farming by remarking that it makes very little economic sense from a farming standpoint, to run a tractor around the many point rows that jut out into the meander bends of the stream. They yield poorly because of shading and competition from the oaks in the riparian corridor, and get flooded. Interviewees claim that it is instead the finance department in their companies who pressure them to farm every acre possible.
